**ON THE PERFORMANCE OF BUILDINGS
IN HURRICANES
A STUDY FOR THE SAFFIR-SIMPSON SCALE
COMMITTEE**

by Tim Marshall, P.E.

HAAG ENGINEERING CO.

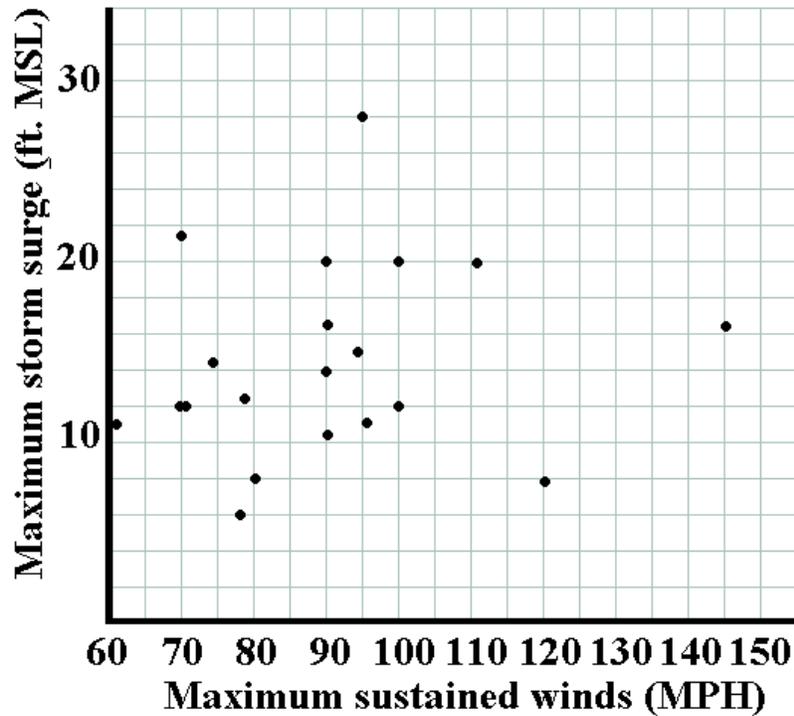
Figure 1. Plot of peak storm surge with maximum sustained (1-minute) winds for 20 hurricanes. The wide dispersion demonstrates there is poor correlation between wind and surge levels.

In the author's study of storm surge, it has become obvious there is not a direct relationship between the magnitude of the wind and the height of the storm surge. There are many reasons for this including the size of the hurricane, angle of its attack to the shoreline, coastal topography, bathymetry, etc. Thus, the Saffir-Simpson scale, which correlates wind speed to the height of the storm surge, has a high error rate. For example, a relatively weak hurricane like Iwa in Hawaii in 1982 had a surge of about 20 feet MSL with wind gusts of about 85 MPH. In contrast, a strong hurricane like Charley in Florida in 2004 had a surge of about 8 feet MSL with wind gusts of about 135 MPH. Thus, it is the author's opinion that the storm surge portion of the scale should be detached from the wind portion. Refer to Figure 1 and Table 1.
